ST0888/1-V2

Face load pressure box tests of the Flashman Bevelbord aluminium weatherboard system

This report describes the face load pressure box testing performed on a FLASHMAN wall cladding system where the FLASHMAN Bevelbord aluminium weatherboard was screwed through battens to timber studs. The purpose of this testing was to determine the design level of differential pressure able to be resisted by the FLASHMAN Bevelbord wall cladding system.

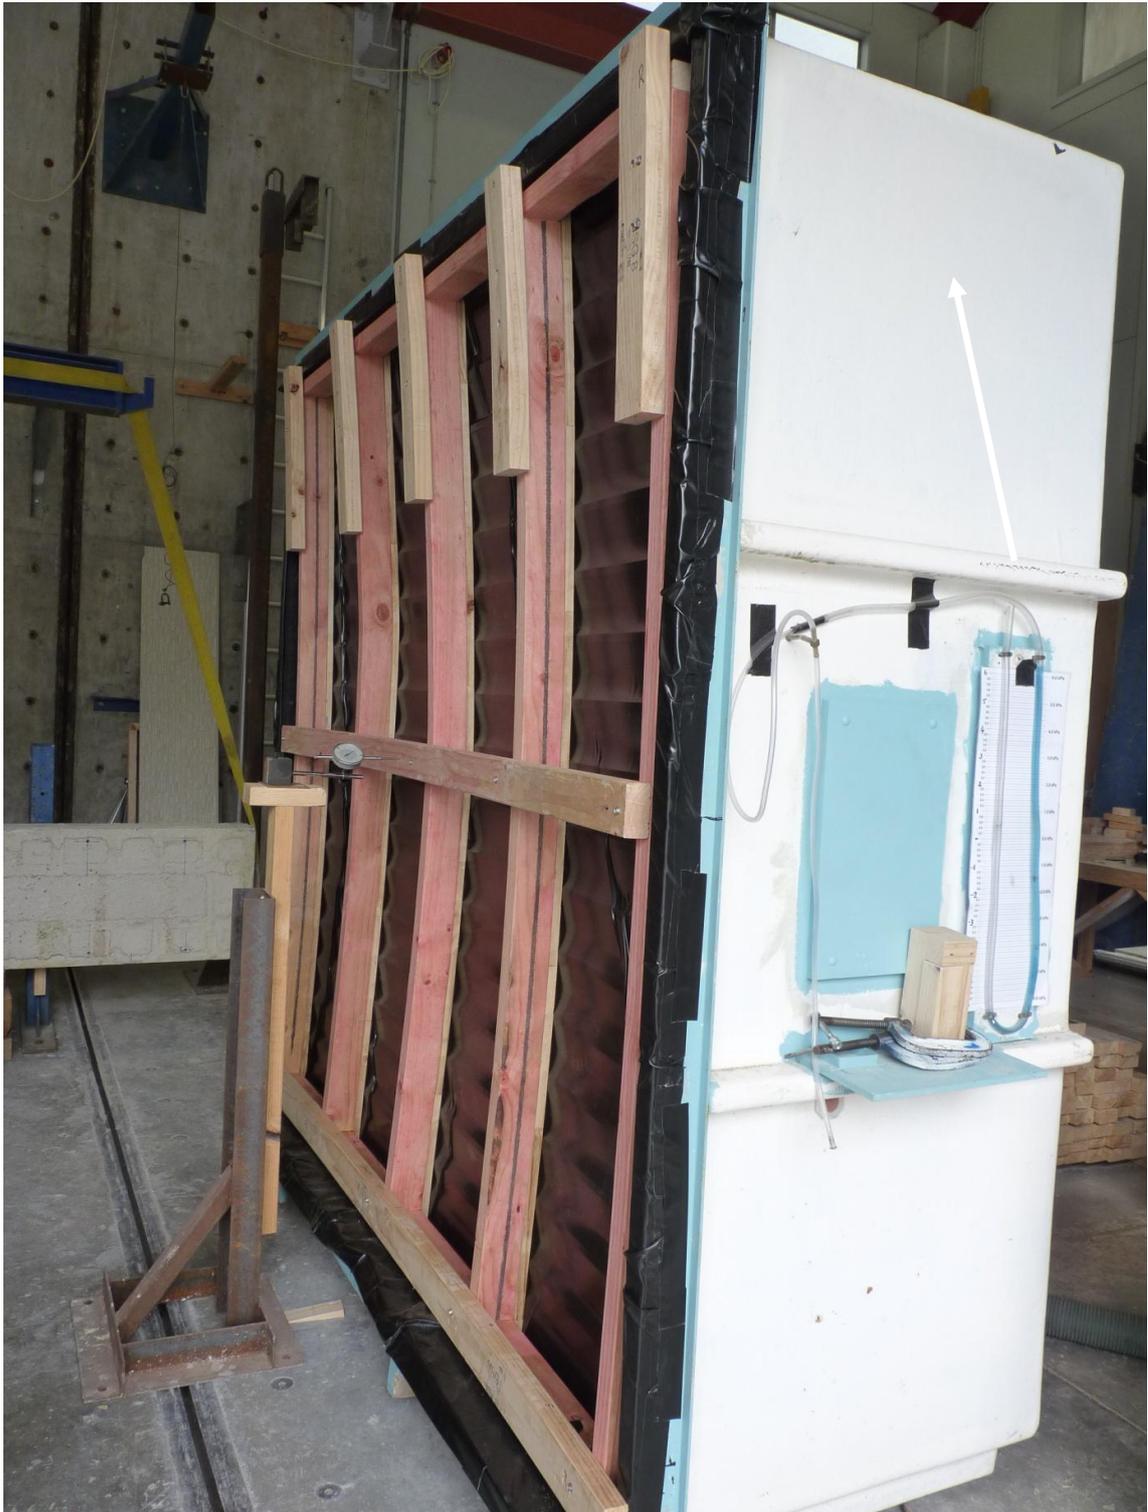
Figure 1. Test specimen in pressure box under high suction load. Note, curvature of studs.

The specimen size was selected to fit into the opening in the laboratory pressure chamber. The framing was constructed from 90 x 45 mm MSG8 radiata pine timber. Studs were at 600 mm centres and were affixed to the top and bottom plates with two 90 x 3.15 mm power driven nails. No nogs were used. 45 x 20 mm radiata pine battens were nominally fixed through the battens to the external face of the framing. Each specimen had a sheet of 250 µm plastic installed between the external face of the battens and the back face of the aluminium boards as shown in Figure 1 to Figure 3 to maintain air tightness without affecting specimen strength.

As can be seen in Figure 1, to help prevent failure of the studs and stud-to-plate connections, the following frame strengthening was used:

The specimens were tested under negative pressure applied to the chamber shown in Figure 1 corresponding to "suction" on a building. The pressure was applied in increasing steps of 0.1 kPa. Each pressure step was held for one minute. The pressure was then released back to zero for 15 seconds before the next level of pressure was applied to the specimen. This test procedure is based on AS 4040.2:1992 [3].

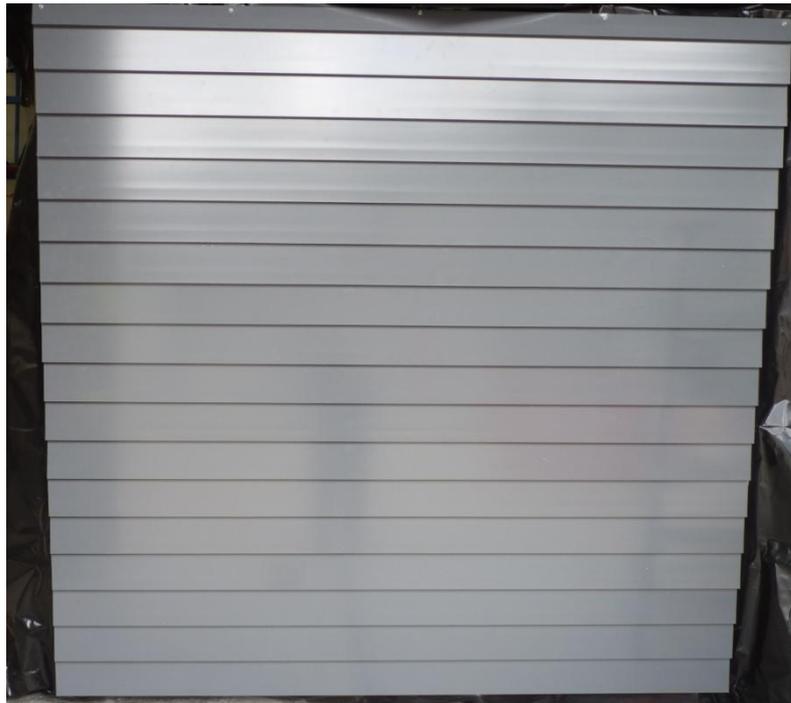
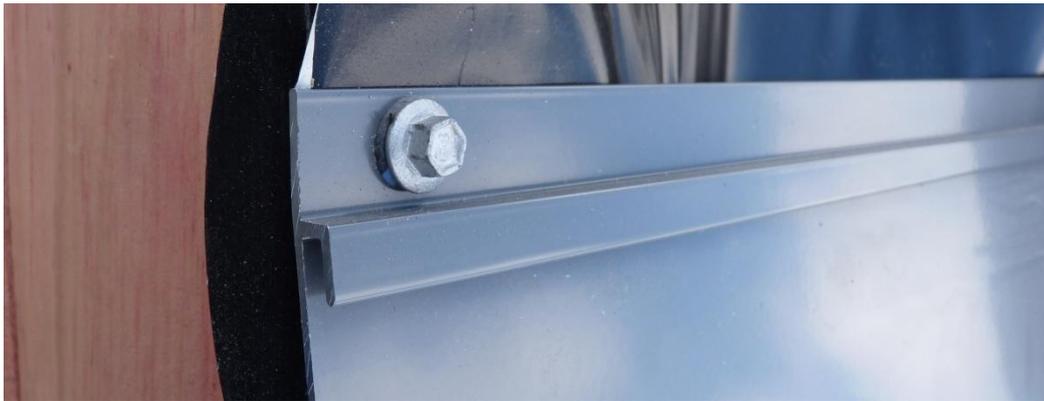
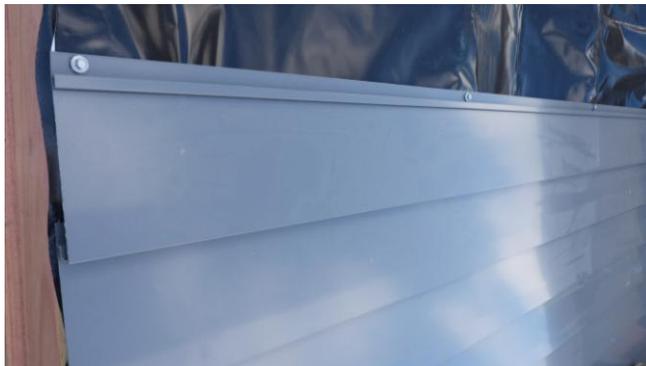
Figure 2. General view of metal cladding and cladding fixing

The framing was clad with FLASHMAN Bevelbord aluminium weatherboards. Each board was screwed to each stud with one Tek screw as shown in Figure 2 and Figure 4. The aluminium weatherboards have a nominal thickness of 2 mm and an overall width of 165 mm. The cross sectional details are shown in Figure 3 and Appendix B.

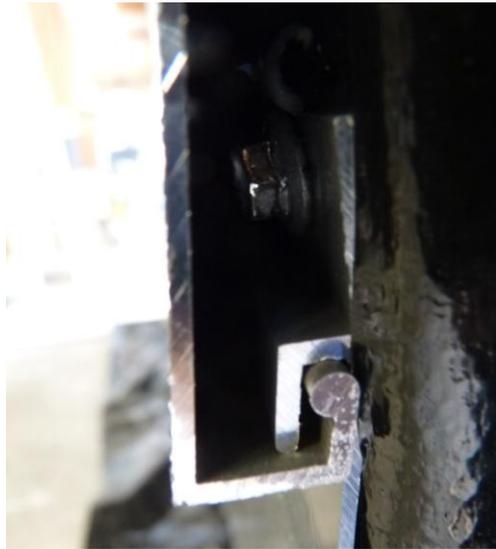
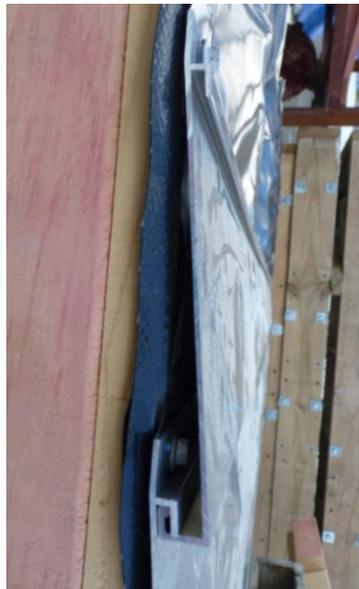
Figure 3. Sectional views through cladding

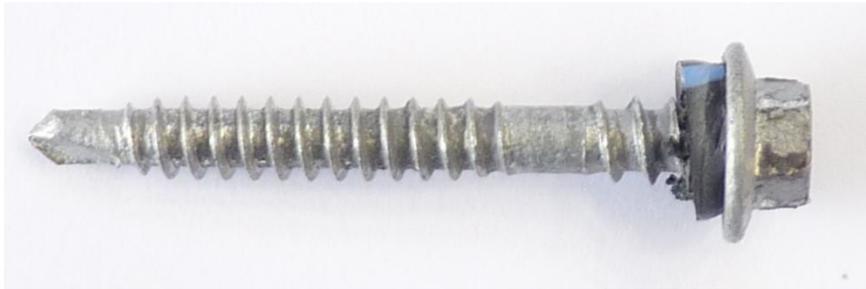
Figure 4. Tek screw used to fix cladding to timber framing. Measured overall length = 55 mm, 14 mm steel washer under hex head, 4.8 mm outside thread diameter

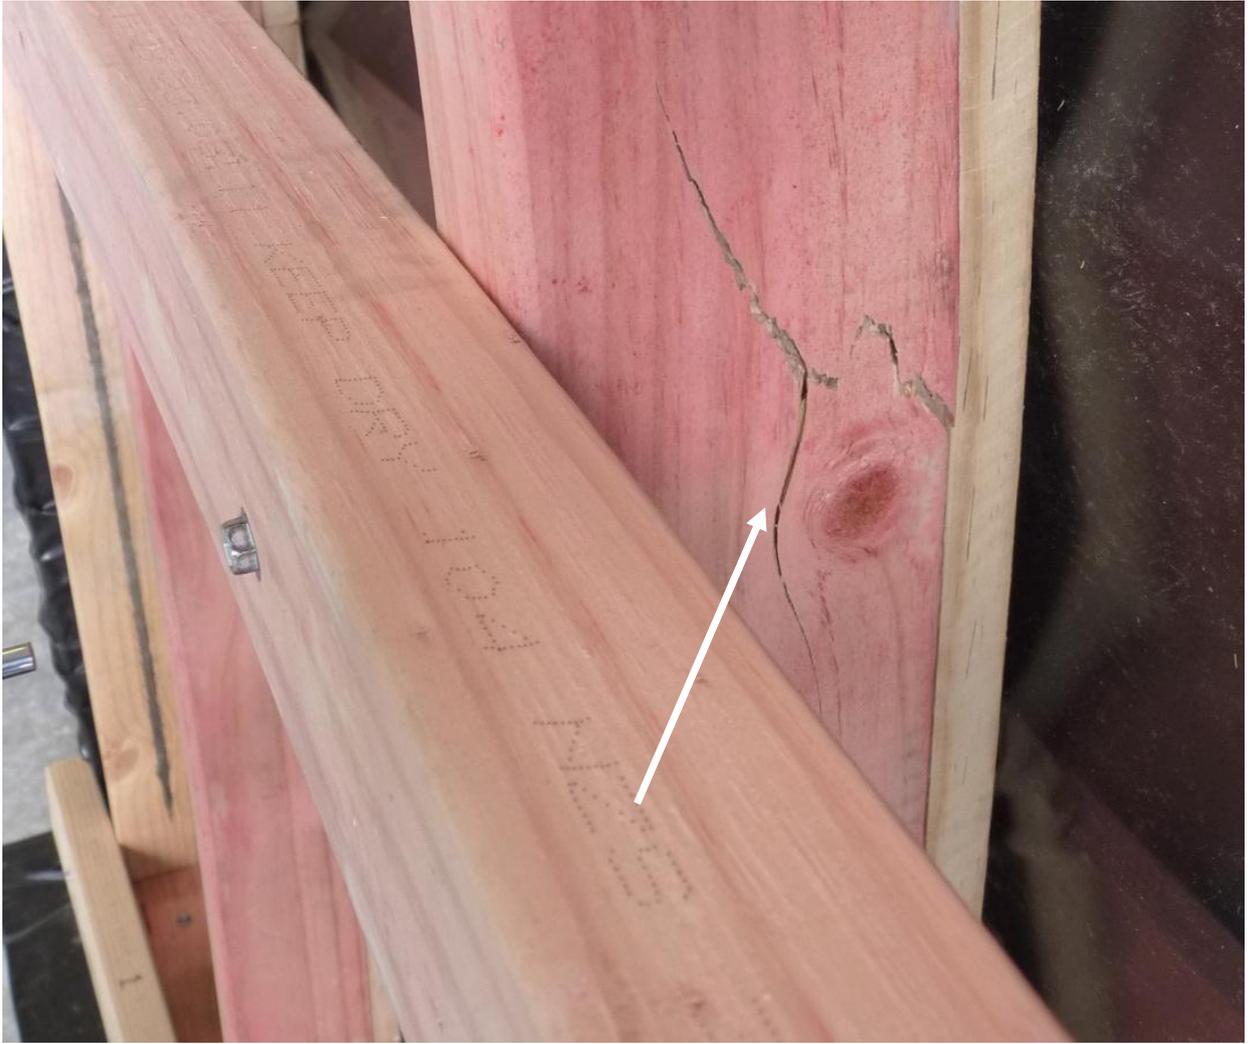
Figure 6. Failure of timber stud in Test 1

The maximum pressure resisted for at least one minute was 6.3 kPa. The test was then stopped as this was the limit of the test equipment. At 3.9 kPa one stud failed at a knot (see Figure 6). A second stud failed at 5.9 kPa and some gaps were noted between battens and boards.
